**HARLOW BROOK NO. 1 DAM
MA 00032**

**PHASE I INSPECTION REPORT
NATIONAL DAM INSPECTION PROGRAM**

APRIL 1979

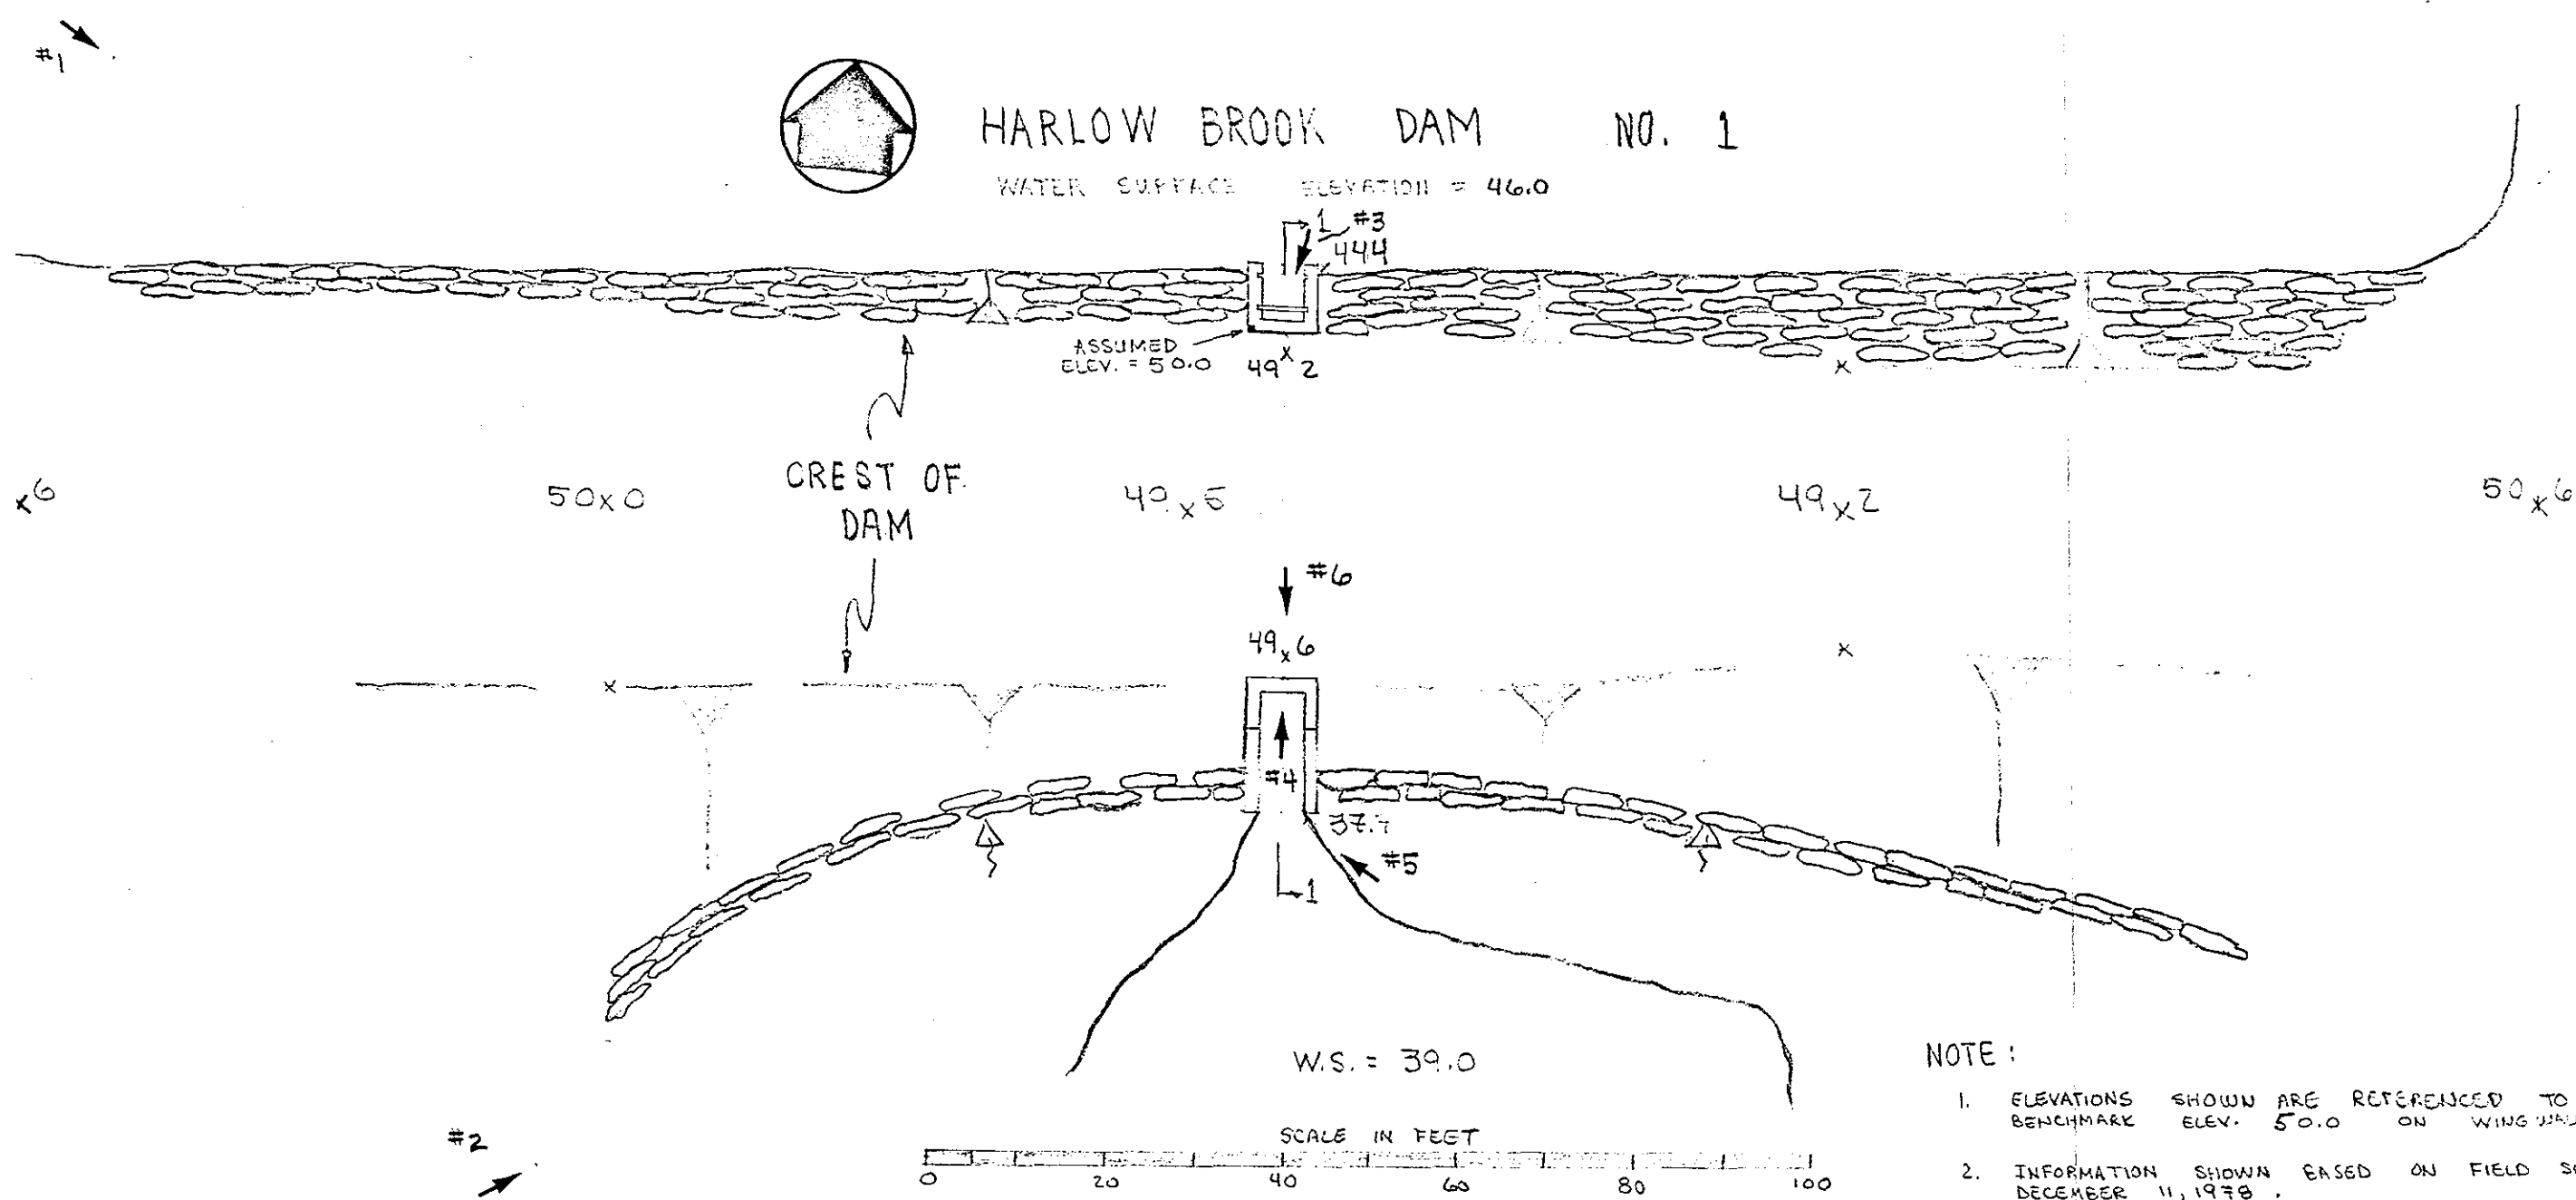
- b. Dam. Harlow Brook Dam No. 1 is an earthfill dam with an outlet structure through the center of the embankment. Seepage through and under the dam has formed a small pool at the toe about 30 feet west of the discharge channel. The water in this pool is colored orange. A hole was observed at the toe of the dam about 45 feet east of the discharge channel. This area was wet. The hole was circular but could only be probed to a depth of 1 foot. The hole was possibly caused by seepage under the dam or is an abandoned outlet pipe. Seepage from this hole has eroded a small gully 3 to 6 inches deep.

The upstream slope is covered with riprap. The stones range in size from 6 to 18 inches. The slope and riprap are both in good condition. A stone wall protects the bottom third of the downstream slope from the discharge water which is immediately ponded by Harlow Brook Dam No. 2. The wall consists of stones 6 to 30 inches in size. Stones are missing in the vicinity of the discharge conduit. The upper two-thirds of this slope is protected by vegetation. This vegetation is growing close together and bare soil is exposed. Surface runoff has cut gullies 2 to 4 inches deep in the slope. This slope is in fair condition. Vehicular traffic
